RECORD CARD FOR SECULAR MONUMENTS.

1. Name and situation of Monument (with owner's Name and Address). Lower House Farm in Olchon Valley just over  $\frac{3}{4}$  mile S.S.E. of Church.
2. General appearance: (a) No. of storeys. 2 attic.  
(b) Building materials. Ribbles stone.  
(c) Roofs. Stone slates.

Parish. Llanveynoe

No. of Monument. 13

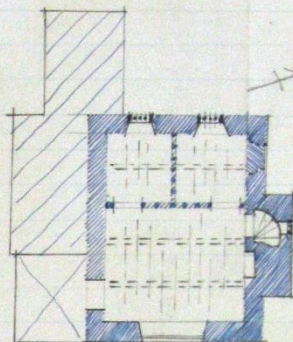
3. Historical development (with dates and small sketch plan).  
A 16th c. house. In modern times additions have been built on against S. side.
