B.**RECORD CARD FOR SECULAR MONUMENTS.**

1. Name and situation of Monument (with owner's Name and Address). *Sneed's Barn
not quite 1½ miles S.S.E. of church (in Olton Valley)*

County. Herefordshire

Parish. Llanveynoe

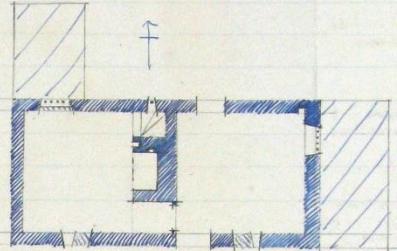
*A late 16th or early 17th c. house
at late date turned into barn
& floors removed from E half.
In modern times additions have
been built on against N & E
walls.*

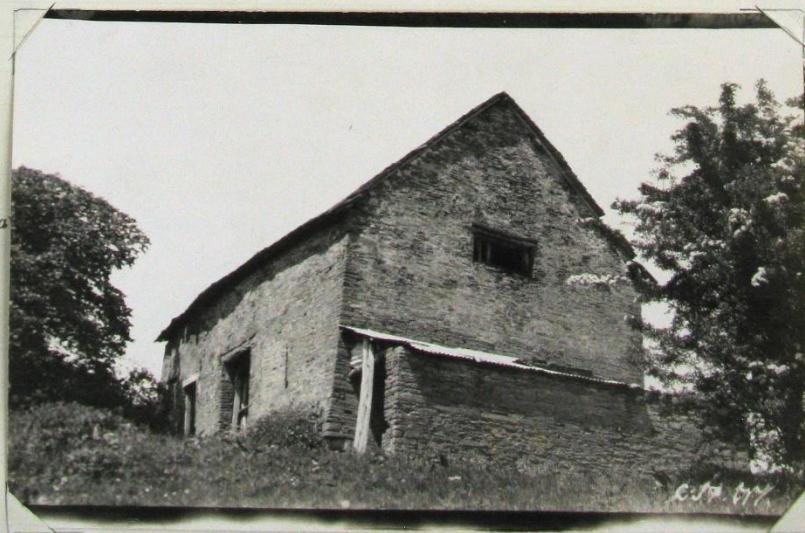
S. Elev. Stone rubble. 2 partially blocked ground floor windows.

E. Elev. Gabled on ground floor is a 5-light diamond mullioned window with stop chamfered mullions & there is a similar window at 1st floor level. The base of gable is battered.

N. Elev. There is a 2-light diamond mullioned window frame to staircase with projecting flagstone label & a ground floor a 5-light diamond mullioned blocked window.

W. Elev. Stone wall up to gable level. Gable covered with modern weather board.
