RGHM Herefordshire Wigmore Monuments 5 to 20

The following monuments, unless otherwise described, are of the 17th century and of two storeys, timber-framed, and with stone, slate or tile-covered roofs. Most of the buildings have exposed external timber-framing and internal ceiling-beams. Condition—Good or fairly good, unless noted.

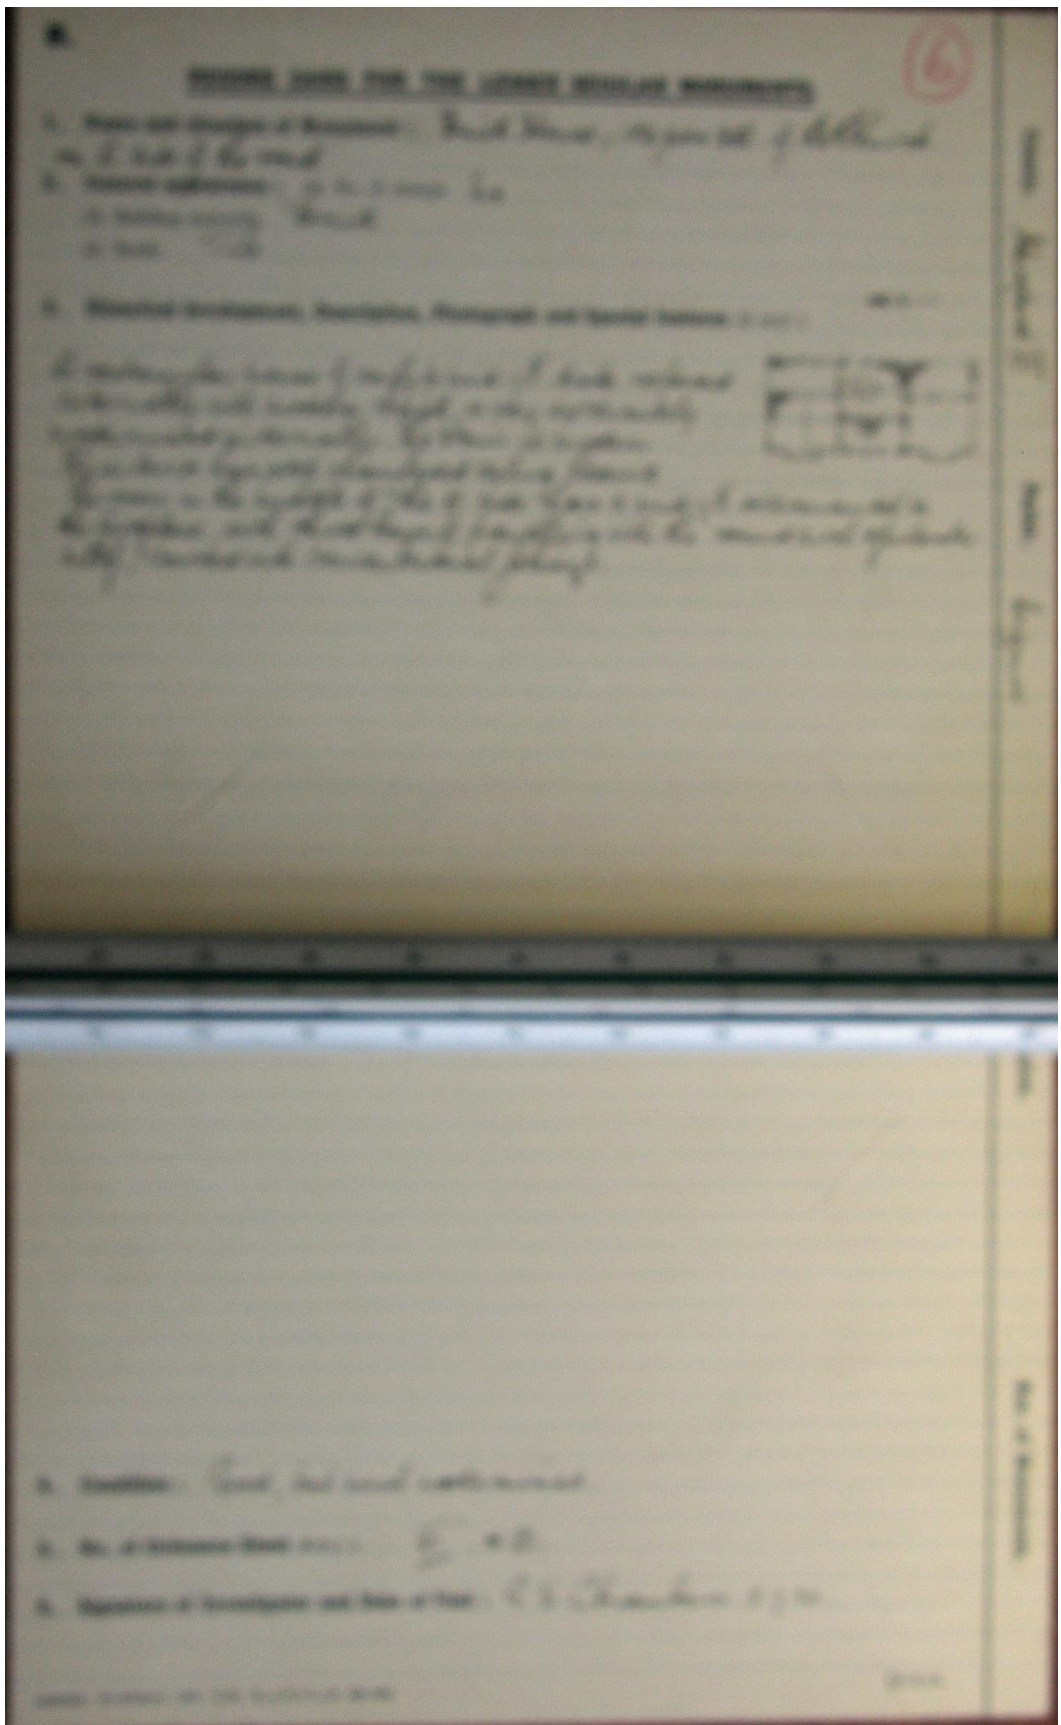
(6). Brick House, 50 yards N. of (5), has been refaced in brick. Inside the building is a 17th-century overmantel with three bays of enriched arcaded panelling. (Photograph unfortunately out of focus)

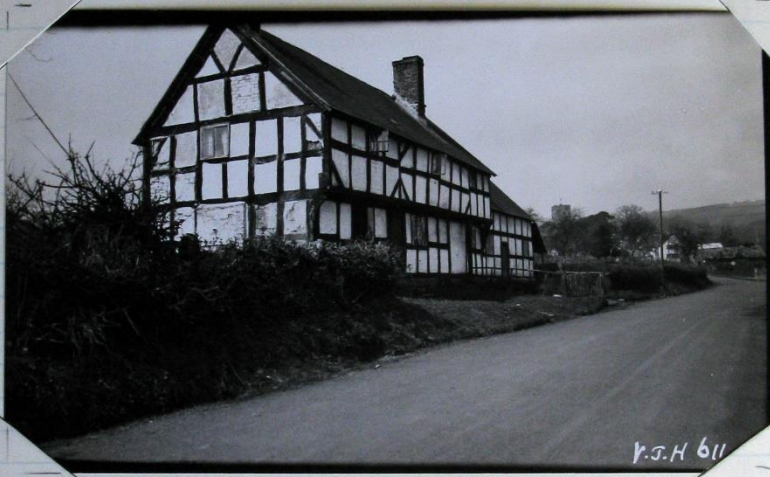
(C) 8

3. Historical development, Description, Photograph and Special features (if any) :
A long rectangular building of c. 1600, with a late 17th E. extension at the W. end, and a small modern addition on the S. side. The timber framing is exposed both internally & externally, the main vertical posts having diagonal braces & struts. The N. wall has an overhanging upper floor with chamfered bressumer, and curved brackets. The S. wall formerly had an overhang, which is now underbuilt.

4. Condition : *Fair.*
5. No. of Ordnance Sheet (6-in.) : VI . N.E.
6. Signature of Investigator and Date of Visit : *G.E. Chambers. 27.4.32.*

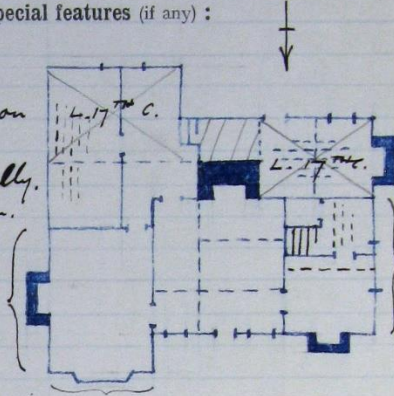
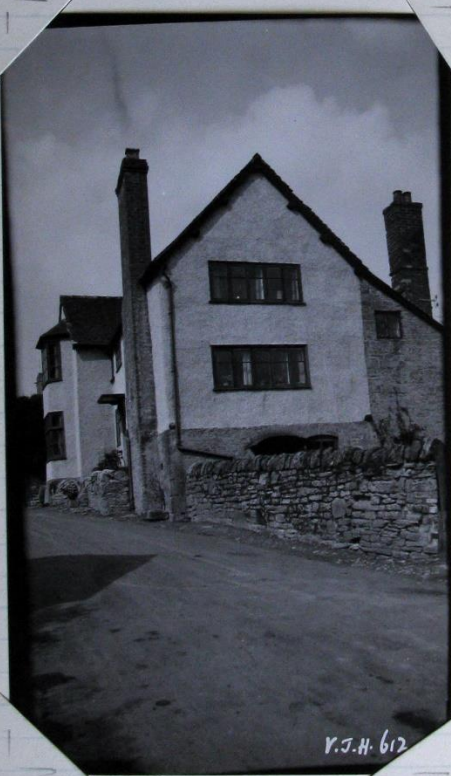
(E) (9)

The original house has a modified T. shaped plan + is of the first half of the 17th C. In the latter half of the same century additions were made on the N. side. The house has been much reconstructed internally + refaced externally, so that little of the original work can be seen. The interior has some stop chamfered ceiling beams

4. Condition : *Good, but much altered*
5. No. of Ordnance Sheet (6-in.) : *VI. N.E.*
6. Signature of Investigator and Date of Visit : *G.E. Chambers.*

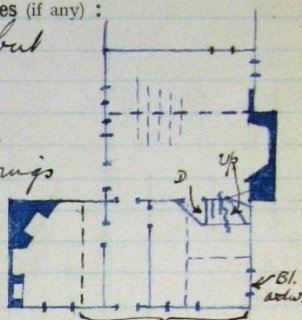
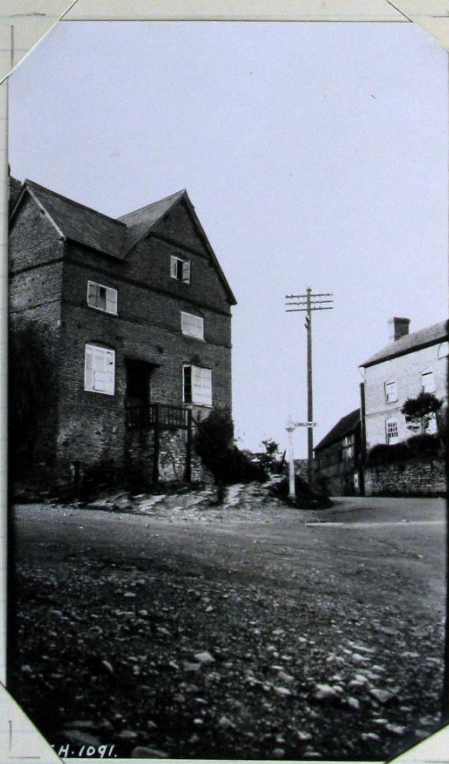
(11)

Out shaped building, probably of mediæval origin but almost entirely rebuilt in the latter part of the 17th c.

The roof has reused timbers which appear to be of early date, and the lower part of the E. wall is of rubble with a chamfered plinth. The 17th c. work is in brick + has strings of brick set diagonally, between the floors.

The S.E. room has some mid 17th c. moulded panelling. The fireplace to the N. chimney stack has a cambered, stop chamfered head; and the ceiling beams are also stop chamfered.

4. Condition : *Poor.*

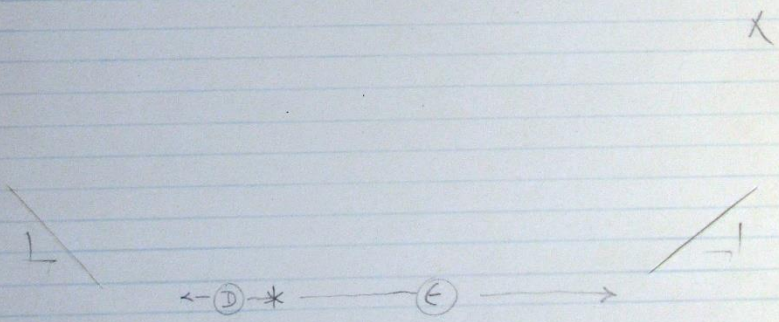
(13)

A small L shaped building, with a 16th E wing.
 The W wing was added in the early part of the following century. The chimney stack to the E wing is a modern addition, and the plaster has been partly replaced by brick wogging. The timber framing is exposed, there are some heavy stop chamfered ceiling beams.
 The roof to the E wing is of King post construction, with braced tie beams.
 The W wing has a Queen post roof.

4. Condition : Fair.
 5. No. of Ordnance Sheet (6-in.) : VI. N.E.
 6. Signature of Investigator and Date of Visit : G. E. Chambers . 5.7.32.

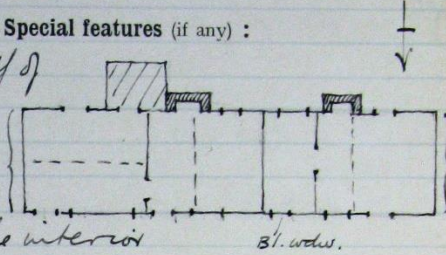
14

A long rectangular building of the first half of the 17th c., with a small modern addition on the S. side. The eastern end has been converted for use as a workshop. The walls have exposed timber framing, with diagonal braces to the wall plates; the interior has stop chamfered ceiling beams.

4. Condition : *Poor.*

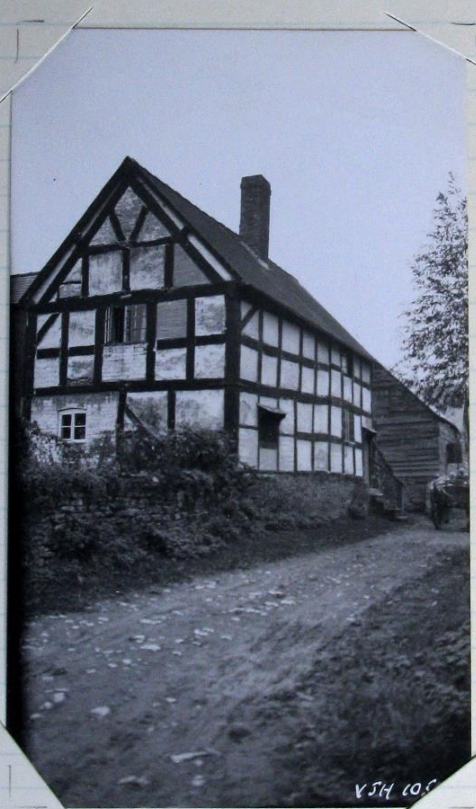
(16)

A rectangular building of the early half of the 17th c., with a modern S. wing. The roof has been rebuilt and heightened. The greater part of the timber framing is exposed both internally and externally. The interior has deeply chamfered ceiling beams & flat joists. The roof is of Queenport construction.

- 4. Condition : *Fair.*
- 5. No. of Ordnance Sheet (6-in.) : *VI N. S. E.*
- 6. Signature of Investigator and Date of Visit : *G. E. Chambers. 3rd 10. 33.*

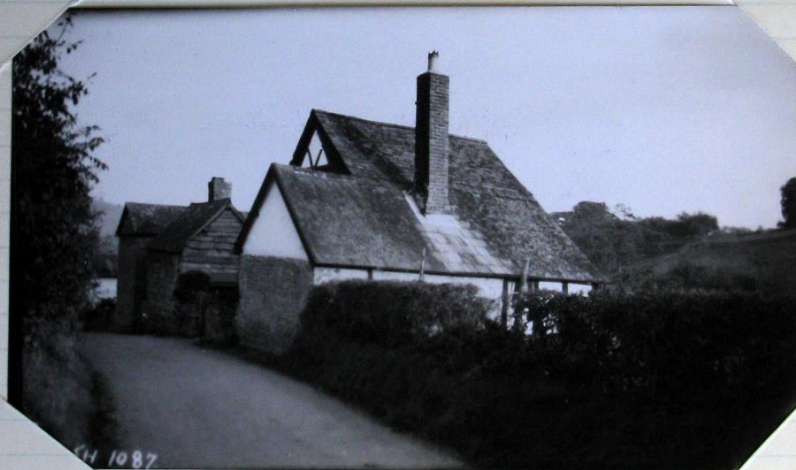
(18)

A small rectangular cottage of mid 17th c. date, with the roof carried down over modern one storeyed additions to the N. + W. The exterior retains some exposed timber framing, but has been partly plastered over, + partly refaced with rubble. The interior has stop chamfered ceiling beams.

4. Condition : Good.

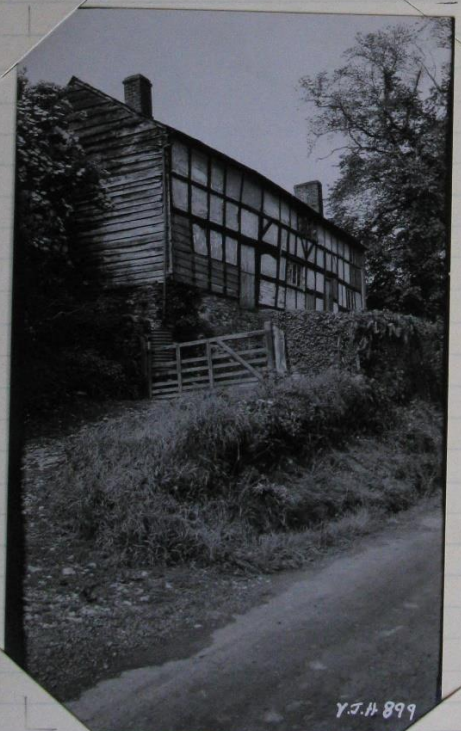
20

A rectangular building of c. 1600. A 17th c. one storeyed extension at the eastern end has recently been pulled down. The first floor has been heightened, the original, green post roof, being incorporated in the new work. The N. wall has exposed timber framing, and, at the E. end, an original, blocked doorway with a triangular head. The S. wall has been patched with corrugated iron, boarding, and modern brick. The W. wall + the chimney stack are of modern rubble. Towards the centre of the S. wall a modern window has been inserted in the side of a door, the stop chamfered frame of which is still in situ. The interior has the timber framing exposed; + stop chamfered ceiling beams + flat joists. There are several panelled doors of 17th c. date.

4. Condition : *Good.*
