RECORD CARD FOR SECULAR MONUMENTS.

1. Name and situation of Monument (with owner's Name and Address). *Whitehouse Farm in Olchon Valley about 3/4 m. S.S.E of Church.*

County. *Herefordshire*

Parish. *Llanveynoe*

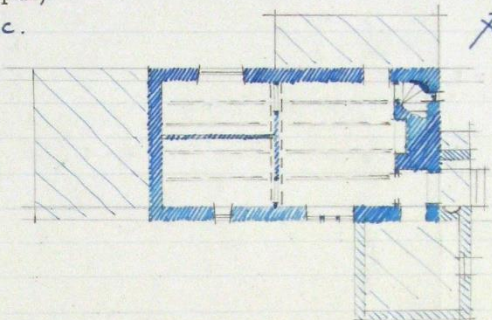
3. Historical development (with dates and small sketch plan).

late 17th c. house. Late in 18th c. a barn was built on at S.W end, a lean-to on N.W side & a new wing & porch at E angle.

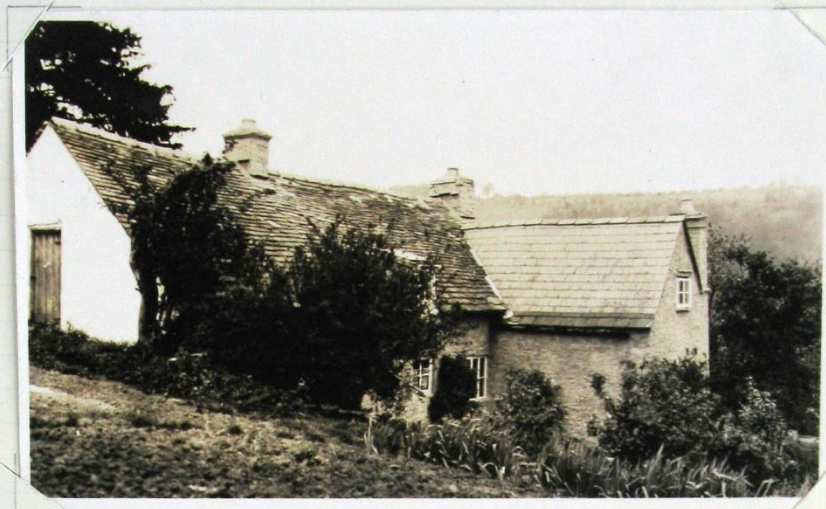
Party window internally has old strap hinges of former shutters now replaced by modern ones.
On ground floor are 3 battened doors of which two have moulded planks.
The stone staircase has thick slab oak treads.
In ceiling above partition on ground floor is a stop chamfered beam supporting four heavy scantling stop chamfered joists or sub-beams.
