RECORD CARD FOR SECULAR MONUMENTS.

County. Herefordshire
 Parish. Llanveynoe
 Sub-Commission. Severn.
 No. of Monument. 123

- Name and situation of Monument** (with owner's Name and Address). *Glan-dŵr in Olchon Valley about 1 mile W.N.W of church.*
- General appearance:** (a) No. of storeys. *1 + attic*
 (b) Building materials. *Stone rubble.*
 (c) Roofs. *Stone slates.*

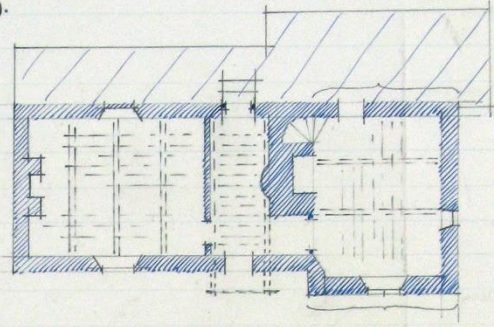
3. Historical development (with dates and small sketch plan).

late 16th or early 17th c. house. In modern times an addition has been built for whole length of W side & the W front of most S room on 1st floor has been raised to obtain 2 stories.

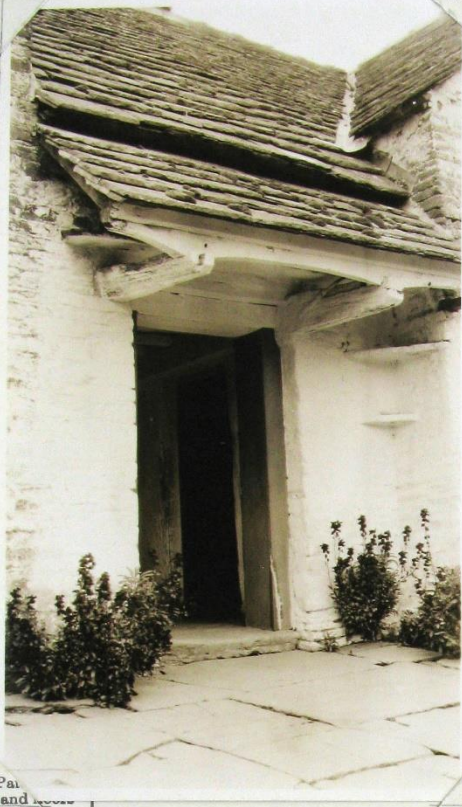
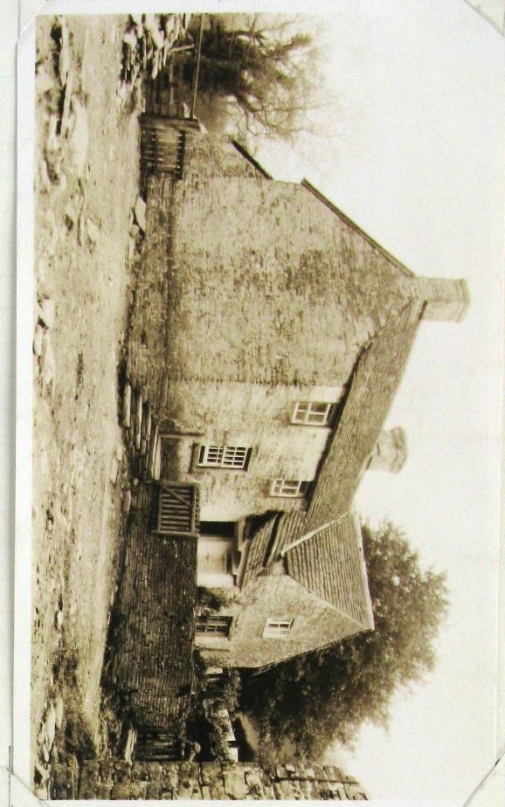
In the main northward room on ground floor is a 17th c. battened door with moulded edges to the planks. On 1st floor is a framed partition in which spaces between framing are filled with large wood panels. Ceilings of ground floor rooms all have stop chamfered beams & exposed joists, the latter in hall-way & N room also being stop chamfered.
