RECORD CARD FOR SECULAR MONUMENTS.

- Name and situation of Monument** (with owner's Name and Address). *Upper Olchon Farm in Olchon Valley & nearly 1 1/4 miles W.N.W of Church.*
- General appearance:** (a) No. of storeys. *1 + attic*
 (b) Building materials. *Rubble stone*
 (c) Roofs. *Stone slates*

County. *Herefordshire*

Parish. *Llanveynoe*

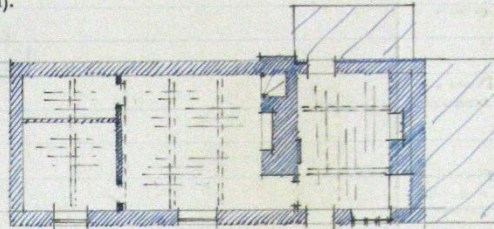
- Historical development** (with dates and small sketch plan).

A late 16th or early 17th c. house. Later in 17th c. a further room was built on at the N.E. end. In modern times a few minor alterations have taken place, additions built on at N.E. end & lean-to on N.E. side.

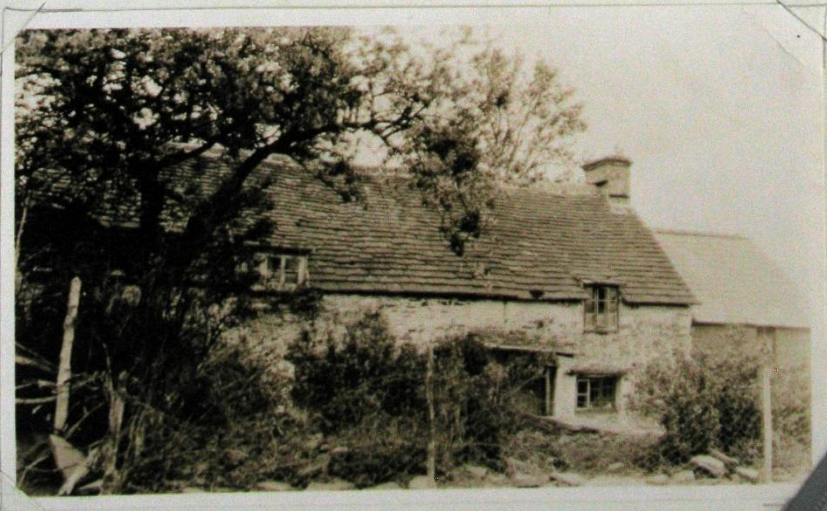
N.W. Elev. There is one blocked window above which is a flag stone label of form →

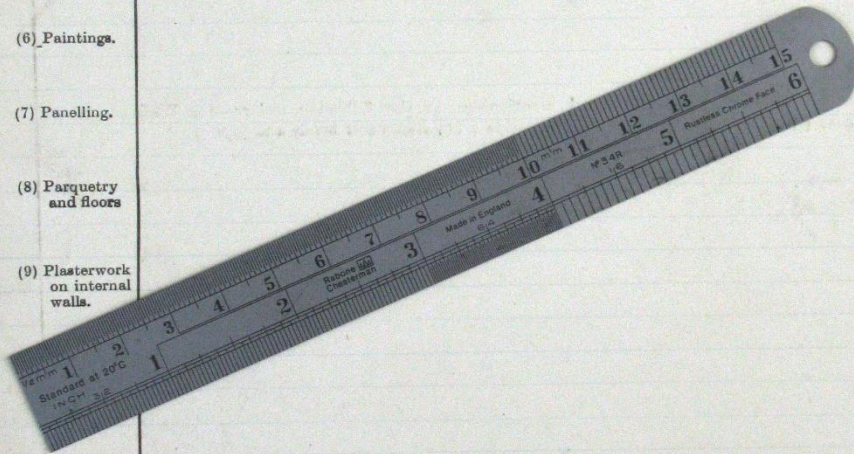
The ceilings of all ground floor rooms have exposed stop chamfered beams re-joined joints. The three doorways in room S.W. of central stack all have segmental headed framing.

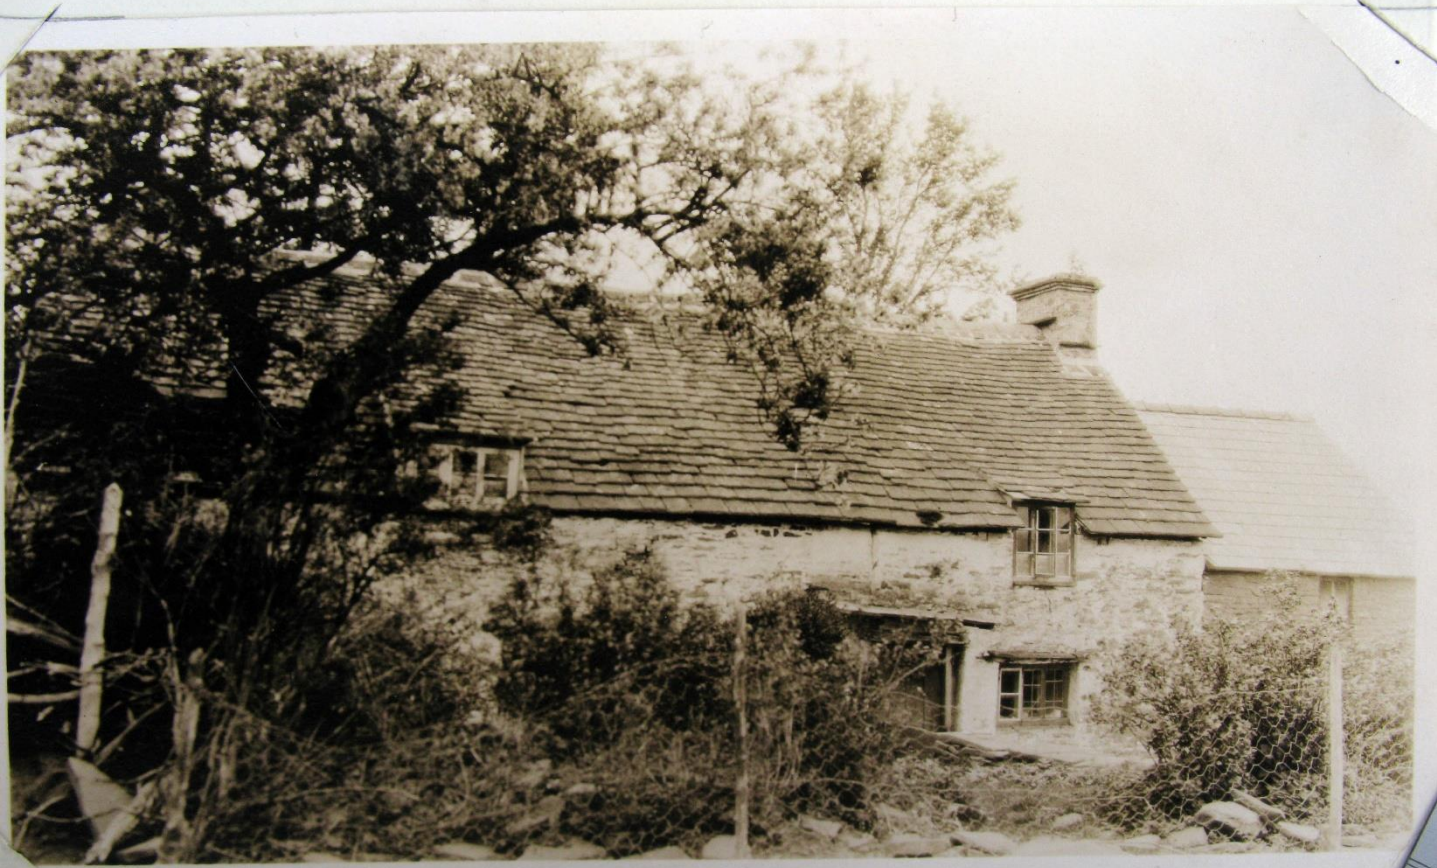
S.W. Elev. Gables. The central stack—formerly the end stack of original house—has square stone shaft with projecting flag stone strings & 2 course projecting cap.

... has (square) ...
y. stone strings & 2 course projecting cap.
