RECORD CARD FOR SECULAR MONUMENTS.

County. Herefordshire
 Parish. Llanveynoe
 Sub-Commission. Secular
 No. of Monument. 3

1. Name and situation of Monument (with owner's Name and Address). *Great Cwm Farm*

600 yds. E.N.E. of Church. (half used as one house actually they are 2 separate houses with no intercommunication)

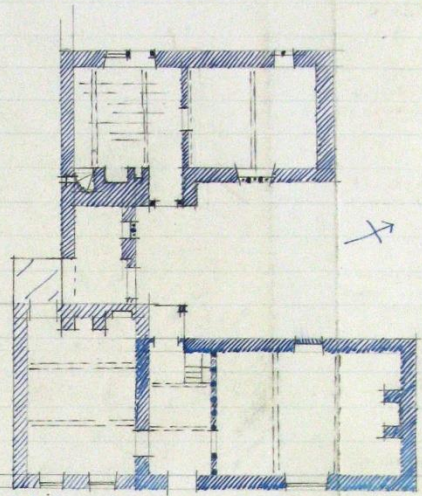
3. Historical development (with dates and small sketch plan).

The E house is 16th c. The wing to same may originally have been same date but would seem more probably to have been added later in any case was entirely re-modelled & heightened in the 18th c. The W house was built late in 17th c.

Between the two houses, & connecting same, is a low 1st storey wash house,

4. Special features (if any). *the S. wall of which would appear to have existed been built at the same time as the W house while the N wall is ~~18th~~ ^{part of} modern.*
