**RECORD CARD FOR SECULAR MONUMENTS.**

1. Name and situation of Monument (with owner's Name and Address). *Old House Barn*

*3/4 mile N.E. of Church.*

Parish. *Llanveynoe*

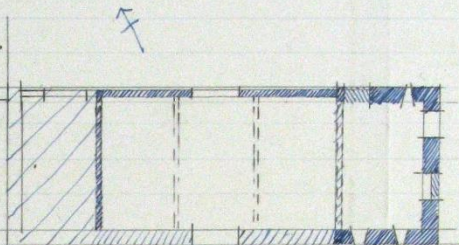
*A 17th c. barn. Probably c. 1700 the most E bay was re-built with stone walls with 'half basement' under. In modern times the S. wall of remainder has been re-built in stone & modern addition built on at W end.*

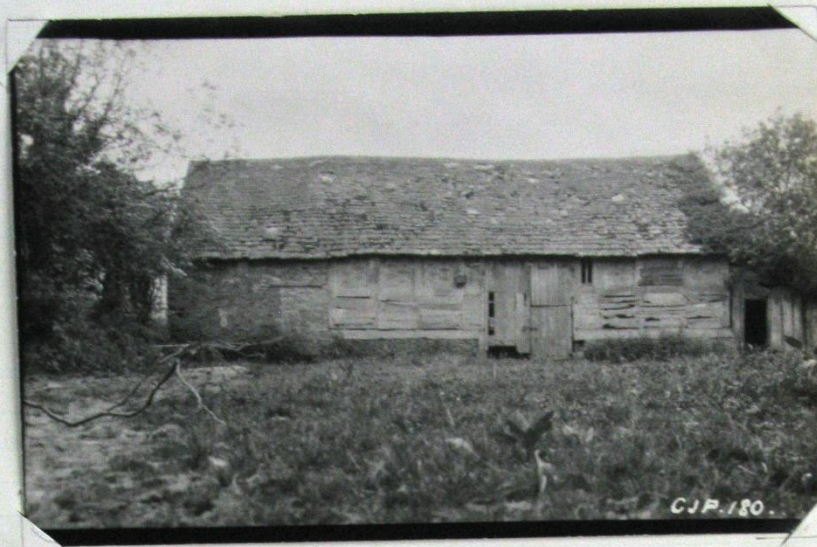
The two cross-partitions are of form →  
while two roof trusses are of  
type →
