**RECORD CARD FOR SECULAR MONUMENTS.**

1. Name and situation of Monument (with owner's Name and Address). *Wern Farm (described used as barn) 1/4 mile S of Church.*
2. General appearance: (a) No. of storeys. *1 + attic.*  
(b) Building materials. *Stone rubble.*  
(c) Roofs. *Stone on S.E. Cor. Iron on N.W.*

County. *Herefordshire*

Parish. *Llanveyneoe*

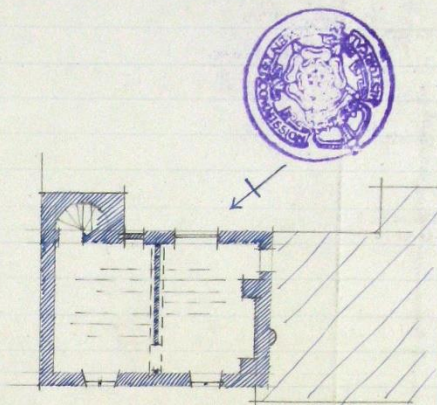
3. Historical development (with dates and small sketch plan).

*a late 16th or early 17th c. house.  
In modern times a barn has been built on at S.W. end.*

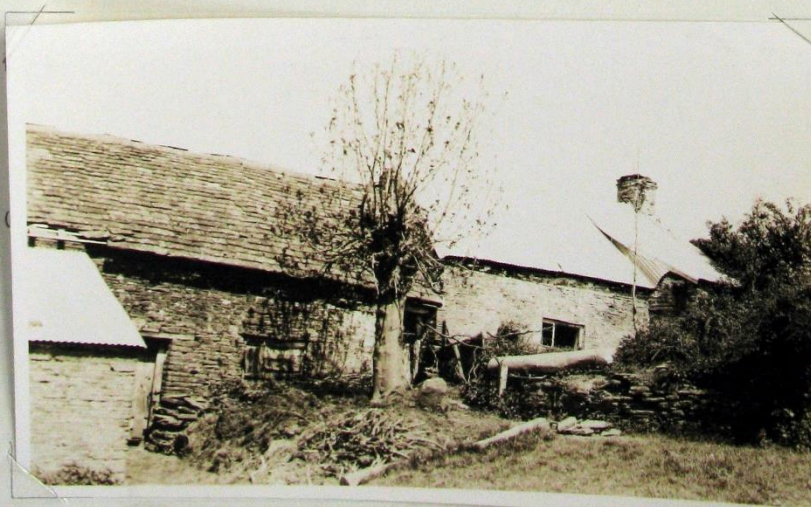
*N.W. Elev. Two ground floor windows have old wood frames + flag stone projecting labels.*

*N.E. Elev. Gabled. Exposed timbers. There is a projecting outside stack to 1st floor with rectangular base supported on stone corbels and square stone shaft with projecting cap. There is a window at 1st floor level with old wood frame.*

*S.E. Elev. On ground floor is a blocked window or window with old wood frame. There is a lean-to roof projecting bay containing a semicircular stone staircase.*

*S.W. Elev. Gabled but mostly hidden by barn.*

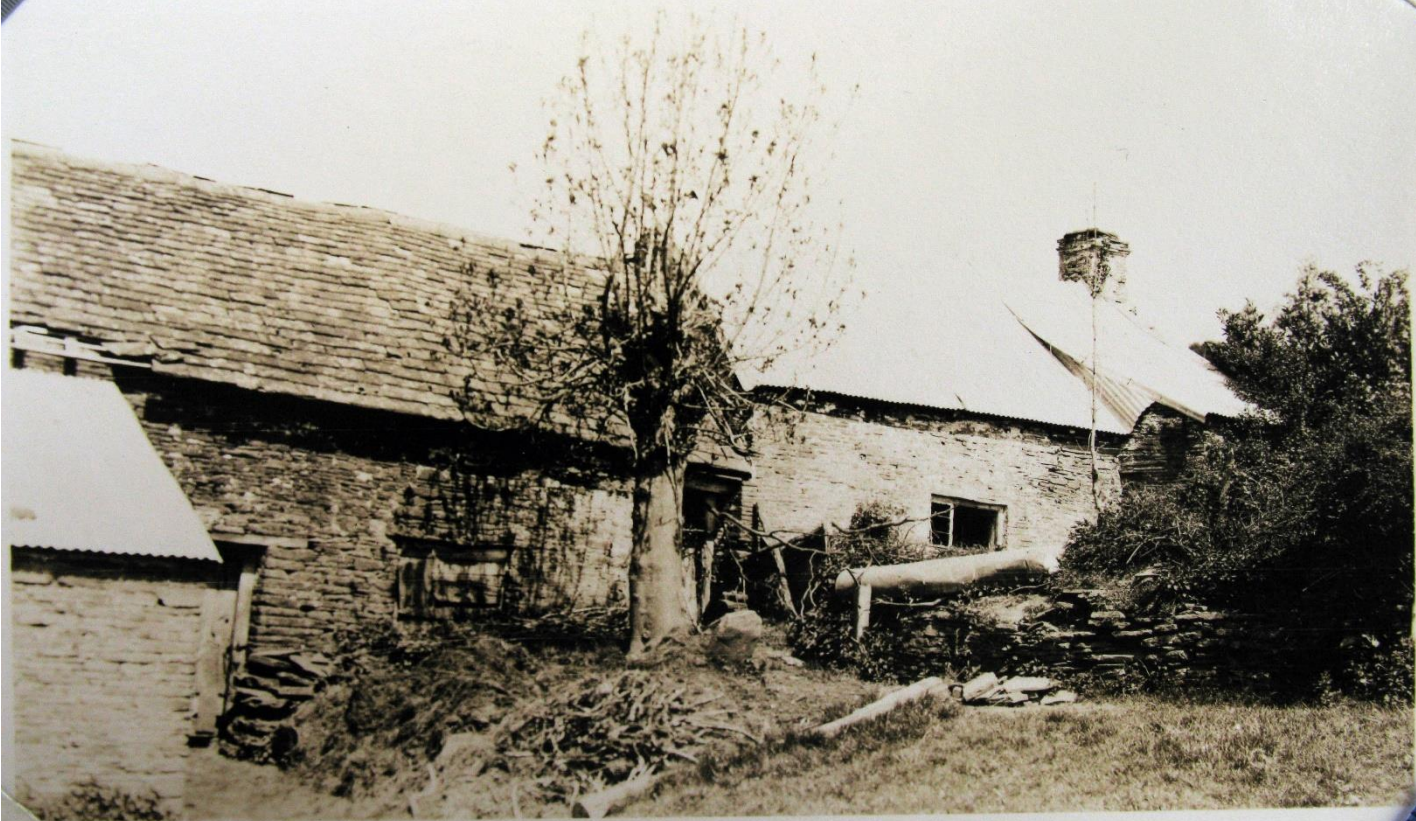
Gabled but mostly hidden by barn.
