RECORD CARD FOR SECULAR MONUMENTS.

County. *Herefordshire*
 Parish. *Llanveynoe*
 Sub-Commission. *Secular*
 No. of Monument. *15*

1. Name and situation of Monument (with owner's Name and Address). *Olchon House in Olchon Valley not quite 1 mile S.S.E of Church.*
2. General appearance: (a) No. of storeys. *2 attic*
 (b) Building materials. *Stone rubble*
 (c) Roofs. *Stone slates.*

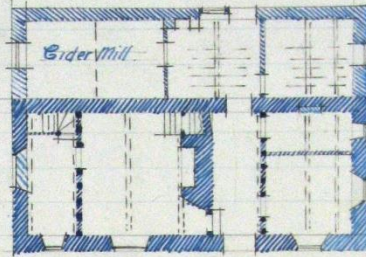
3. Historical development (with dates and small sketch plan).

Probably a 16th c. house. Late in 17th or early 18th it was re-modelled & an addition built along the whole length of the N wall. In modern times this rear lean-to addition was heightened to 2 stories.

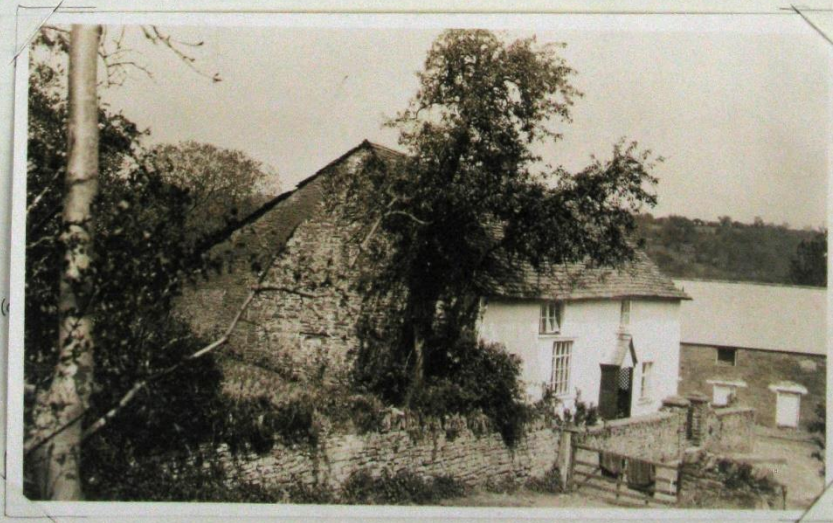
- S. Elev. Rubble. Entrance door has moulded wood frame.*
- E. Elev. Gabled. Exposed timbers. Rebuilt upper wall to rear addition. The wall is battered at base. Attic has old wood frame windows & also a slit window. Stack has been rebuilt.*
- N. Elev. Rubble. Upper part of wall re-built re-roofed.*
- W. Elev. Gabled. Blocked window on ground floor. Wall re-built in upper half of rear addition.*
