## RECORD CARD FOR SECULAR MONUMENTS.

1. Name and situation of Monument (with owner's Name and Address). *Blaen-Olchon*  
*at head of Olchon Valley & about 2 1/2 miles N.W. of Church*
2. General appearance: (a) No. of storeys. *1 + attic*  
(b) Building materials. *Stone rubble*  
(c) Roofs. *W half gable stone slates. Remainder modern slates.*

*Llanveyne*

*27*

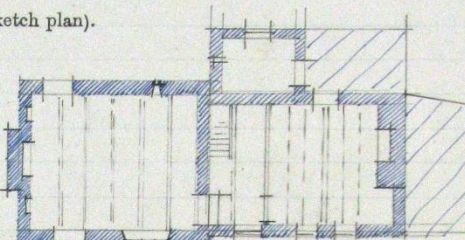
3. Historical development (with dates and small sketch plan).

*The western portion of house is c 1700 while the W half is probably slightly earlier. In modern times it has been somewhat re-modelled.*

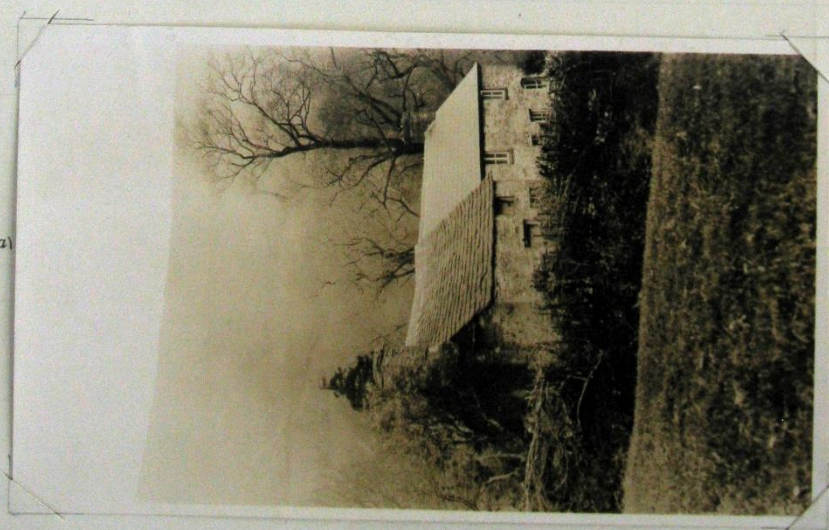
*S. Elev. Stone rubble. 1/3 light casement with wood frame mullions plain on exterior & moulded on interior side (frame repaired externally).*

*W. Elev. Gabled. Rectangular outside stack, weathered on N side, square shaft with projecting string. There is a blocked window to attic.*

*E. Elev. Gabled. Gable partly re-built.*

*N. Elev. Projection has lean-to roof. Immediately E of same is modern lean-to. On ground floor is a small one light square window with wide internal splay.*
