**RECORD CARD FOR SECULAR MONUMENTS.**

1. Name and situation of Monument (with owner's Name and Address). *Pontymoody*

*3/4 mile E of Church.*

County. *Herefordshire*  
 Parish. *Llanveynoe*  
 Sub-Commission. *Seaton*  
 No. of Monument. *1*

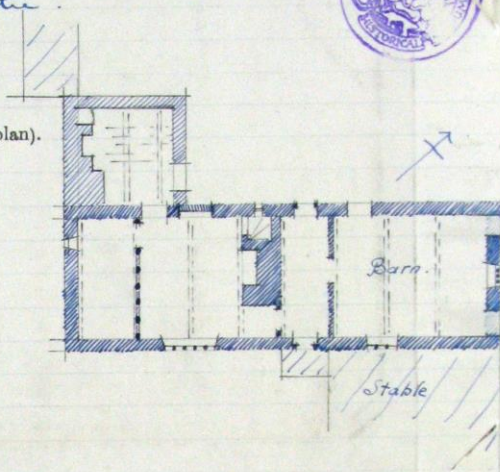
3. Historical development (with dates and small sketch plan).

*A mid 17th c. house. The N.E. portion of which is now used as a barn but which originally formed part of dwelling house. c. 1700 the wing was added. In modern times a stable has been built on against S.E. wall of barn.*
