RECORD CARD FOR SECULAR MONUMENTS.

- Name and situation of Monument** (with owner's Name and Address). *Olchon Farm in Olchon Valley 580 yds. S.S.W of Olchon.*
- General appearance:** (a) No. of storeys *NE of entrance 1 + attic. Remainder 2.*
 (b) Building materials. *Rubble stone.*
 (c) Roofs. *Stone slates to NE half. Mod. slates to SW.*

Herefordshire

Llanveynoe

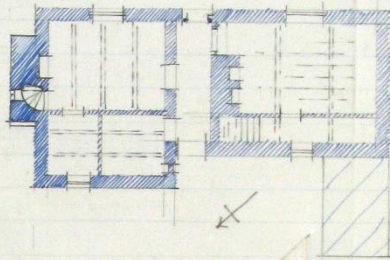
- Historical development** (with dates and small sketch plan).

Probably built ^{late in 16th or early 17th} c. 1600 but re-modelled later in the century. There would appear to have been more re-modelling late in 18th when possibly the S.W portion was raised + also in more modern times.

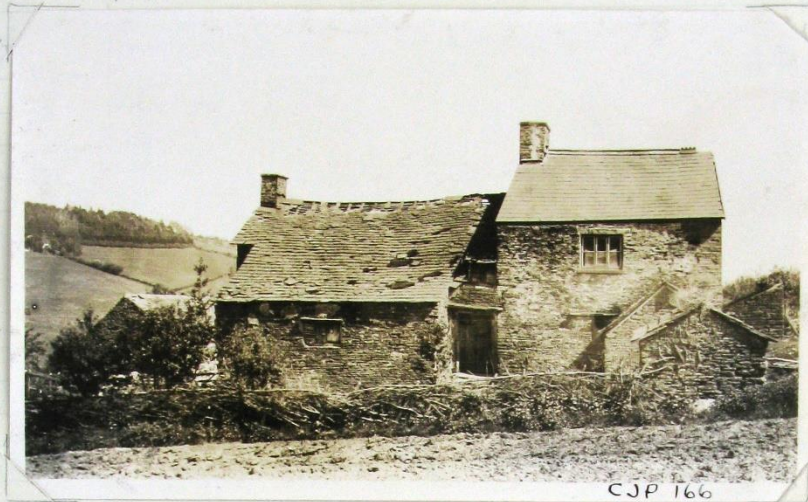
In N.E room are 3 better doors, hung on stop
hinges.
Ceilings of ground floor rooms have exposed
stop chamfered beams some exposed joints in
S.W room.
